Secrets Beneath the Surface: The Use of Full Waveform Capture to Quantify Subsurface Features in Laminated Composites

David A. Jack, Ph.D.

Professor of Mechanical Engineering Baylor University

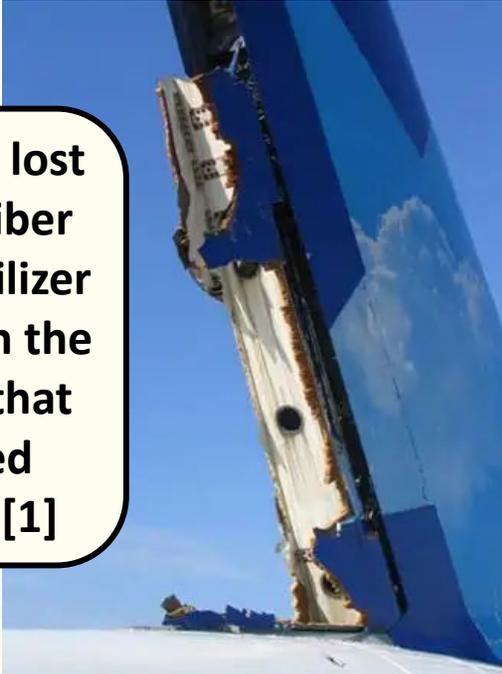
Airbus A310 lost its carbon fiber vertical stabilizer from a gap in the composite that had passed inspection [1]

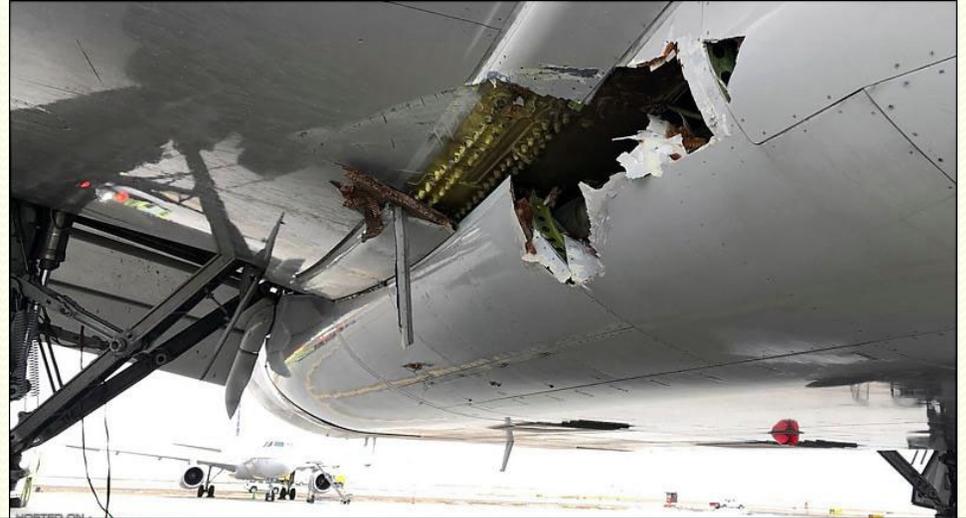
Impact damage from a “Rapid unscheduled disassembly” of an engine cowling over Denver [2]

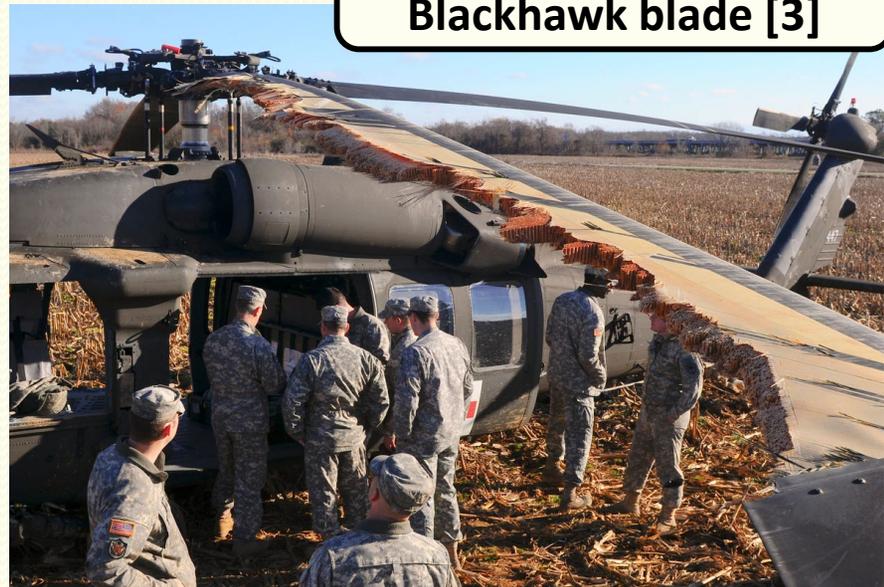
Skin separation for Blackhawk blade [3]

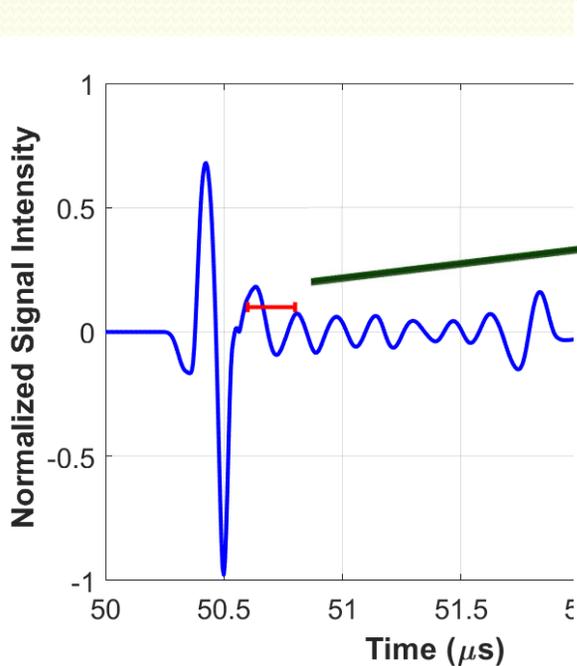
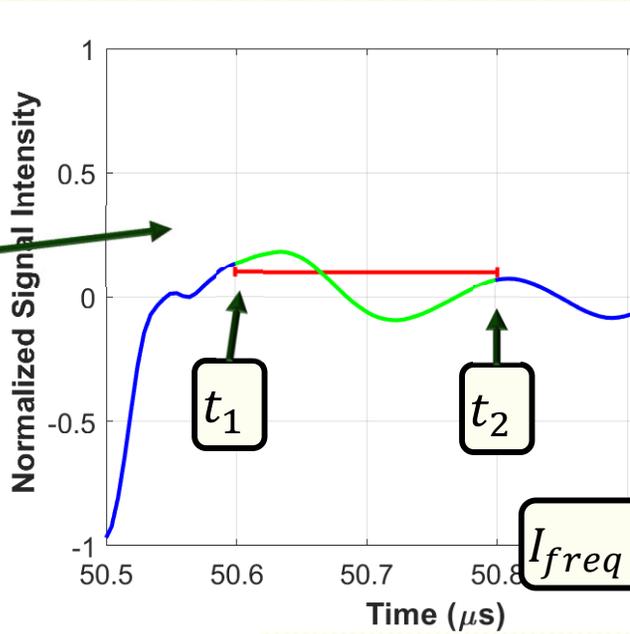
- Most NDE looks at some section of the wave and evaluates some characteristic of the wave over a gate

$$I_{1st} = \text{first}(f(t) > \delta, t \in \{t_1, t_2\})$$

$$I_{max} = \max(f(t), t \in \{t_1, t_2\})$$

$$I_{absmax} = \max(|f(t)|, t \in \{t_1, t_2\})$$

$$I_{energy} = \int_{t_1}^{t_2} f(t)^2 dt$$

$$I_{freq} = \max(\mathcal{F}(f(t))(s), t \in \{t_1, t_2\}, s \in \mathbb{R}^+)$$

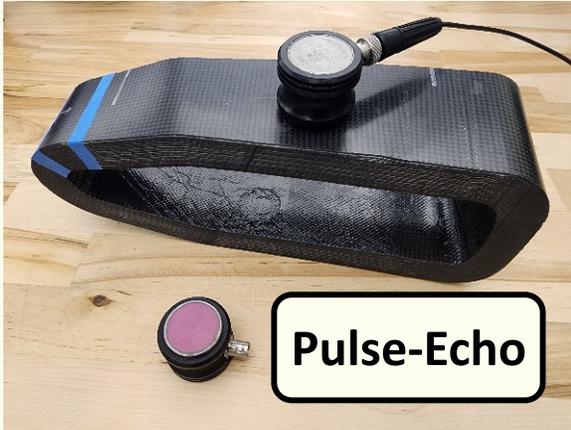
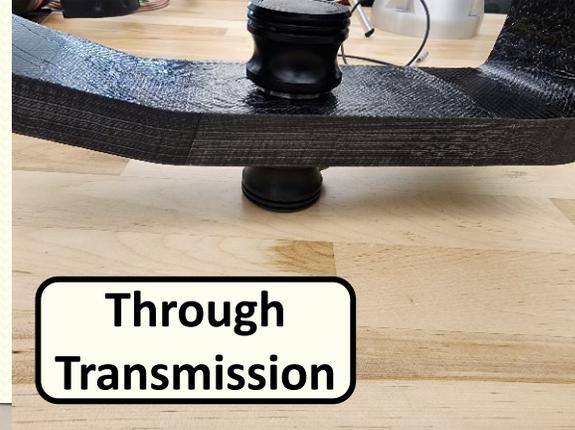
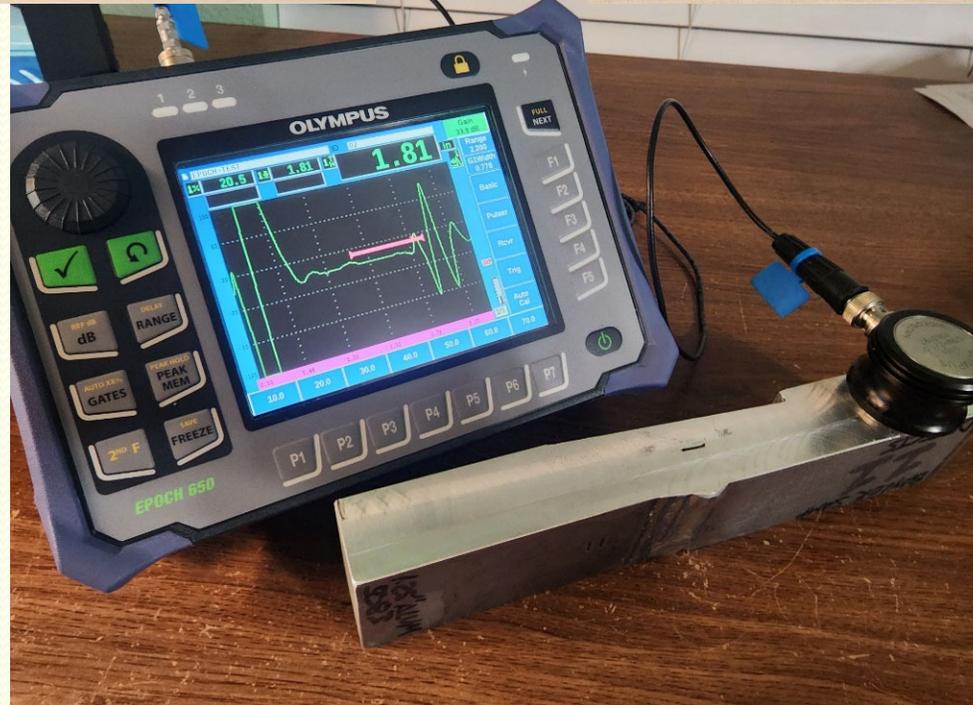
What is Ultrasound?

- Ultrasound uses high-frequency sound energy often generated by a piezo-electric element connected to a digitizer
- Two primary methods, through transmission and pulse-echo

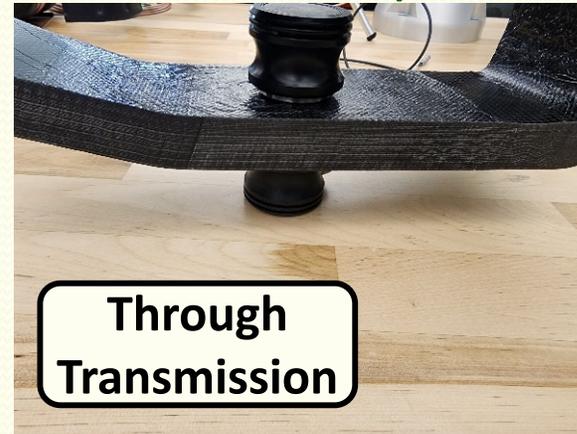
- Ultrasound uses high-frequency sound energy often generated by a piezo-electric element connected to a digitizer
- Two primary methods, through transmission and pulse-echo

- Great for measuring flat-bottom holes, cracks, part thickness.

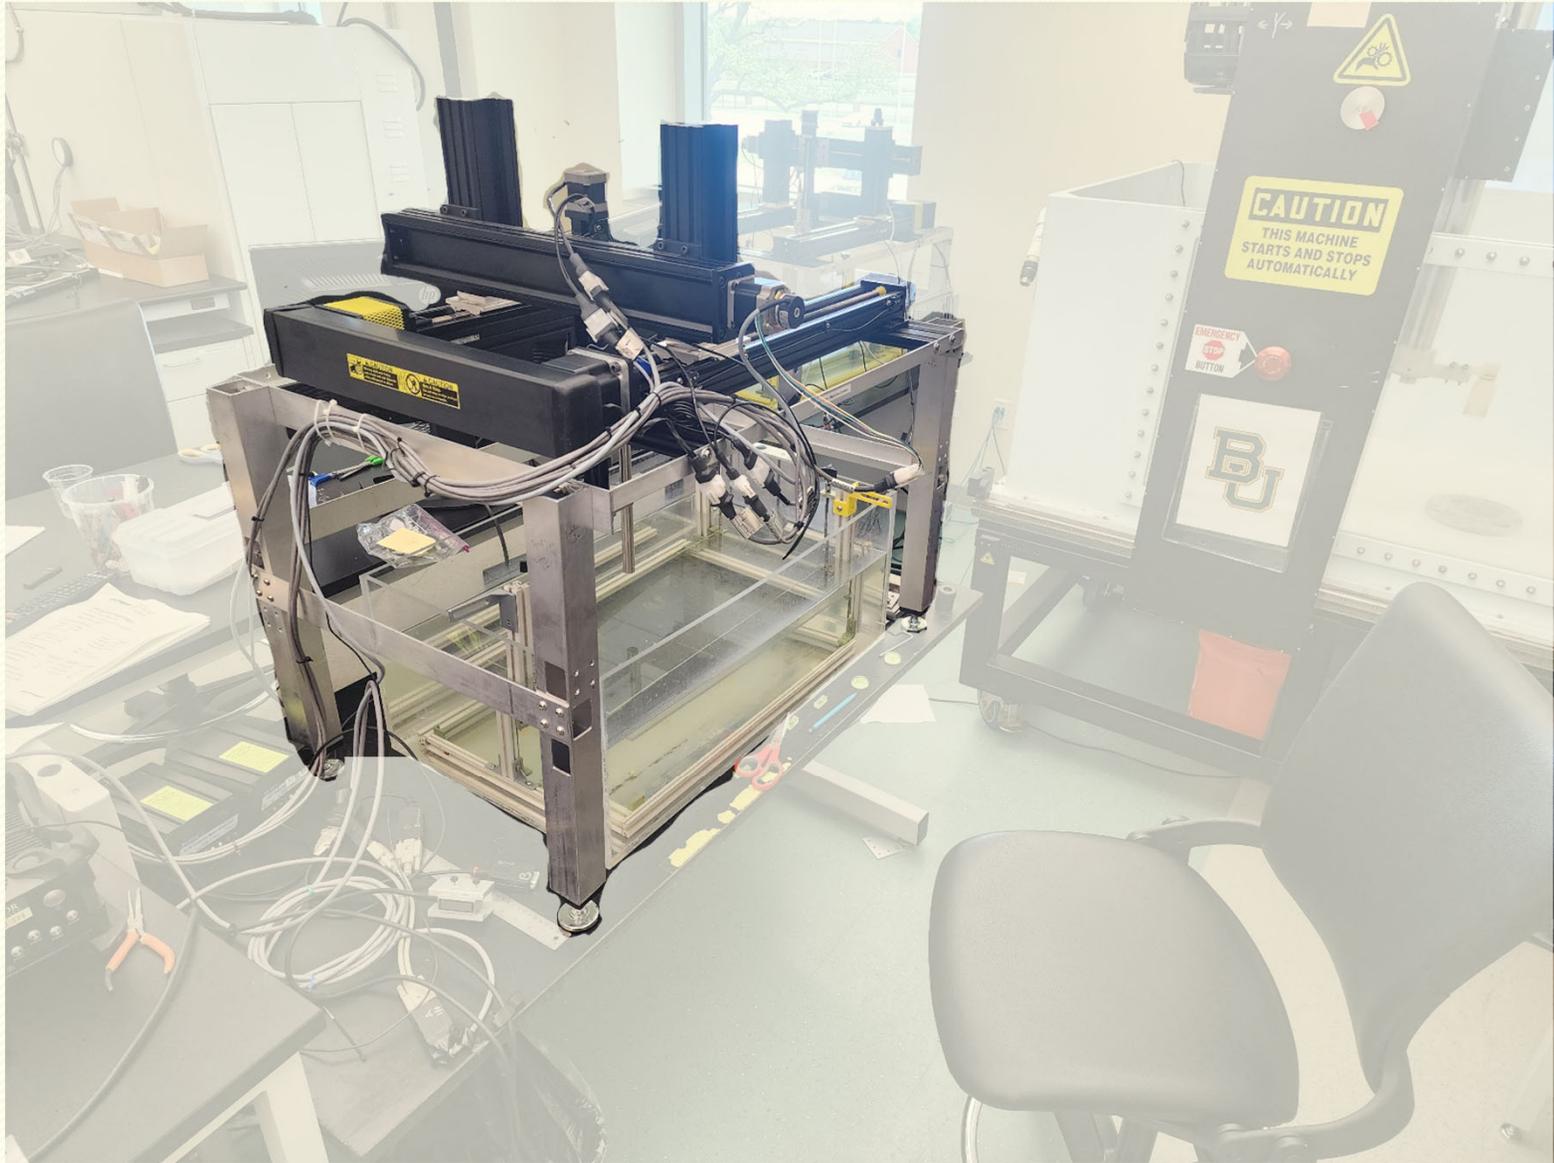
Data Collection System

- Sound travels quite well in water. So, for the best quality images the part is submerged in water

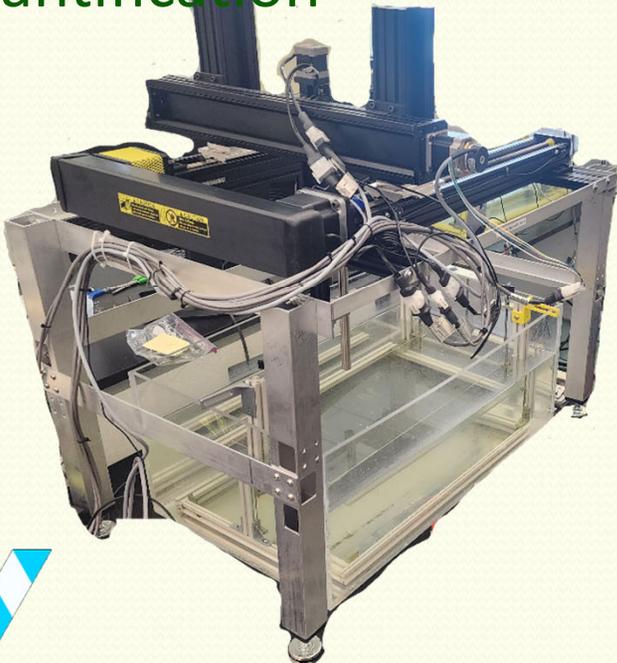
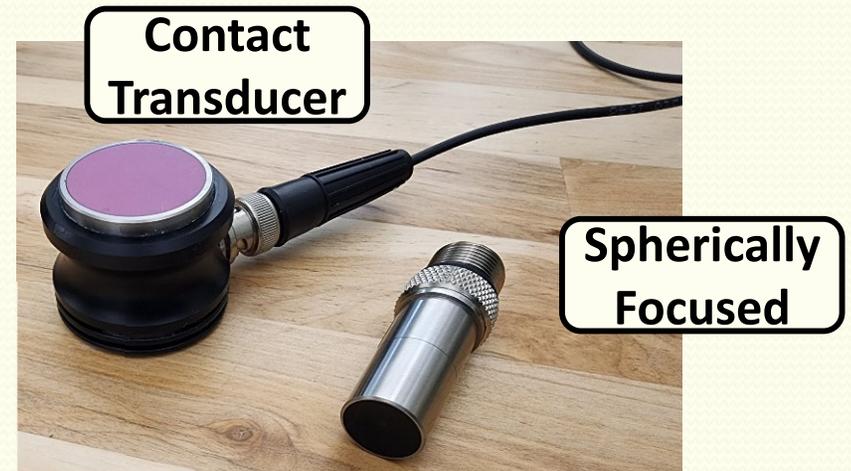
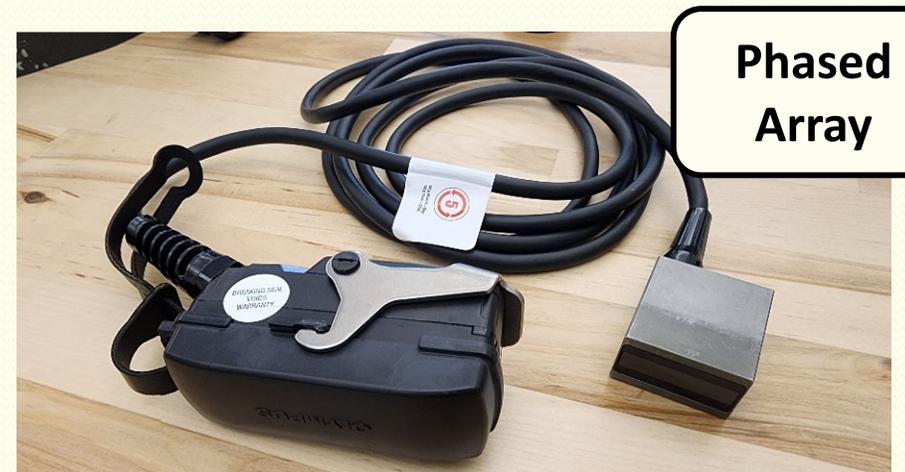
Data Collection System

- Sound travels quite well in water. So, for the best quality images the part is submerged in water
- This also allows us to go from the low-resolution flat-front, contact transducers to high resolution spherically focused transducers or even phased array systems
- Immersion scanning enables quantification

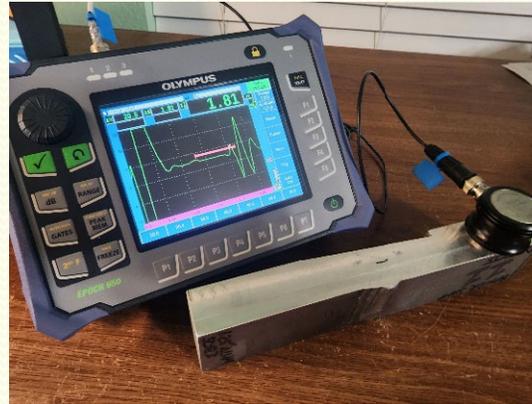
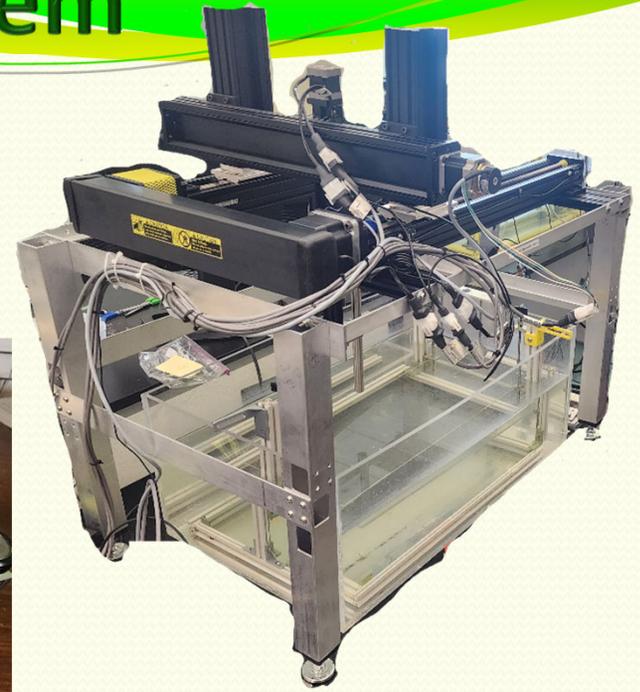
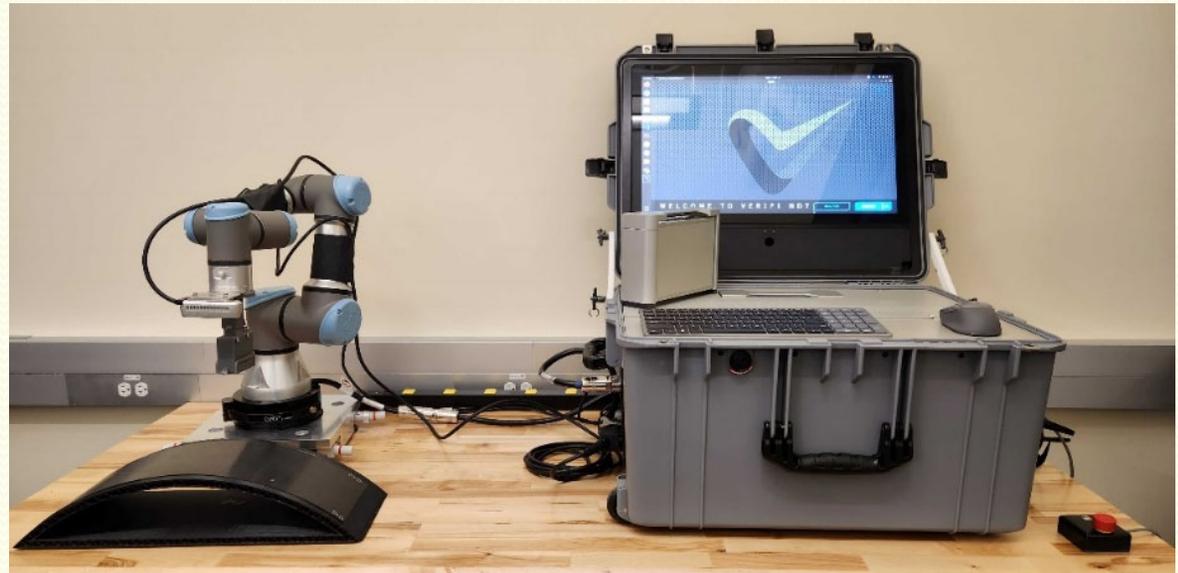
Data Collection System

- Handheld systems are convenient, but limited by poor resolution and by near-surface features
- Immersion systems have high resolution capabilities, but are limited by the need to submerge a part in water
- We have developed the patented and patent pending system, termed the ANDE
 - Field portable
 - Manufacturing environment
 - No need for immersion tank, only a light mist
 - From setup to data collection, it takes ~ 15 minutes to capture and analyze a data source

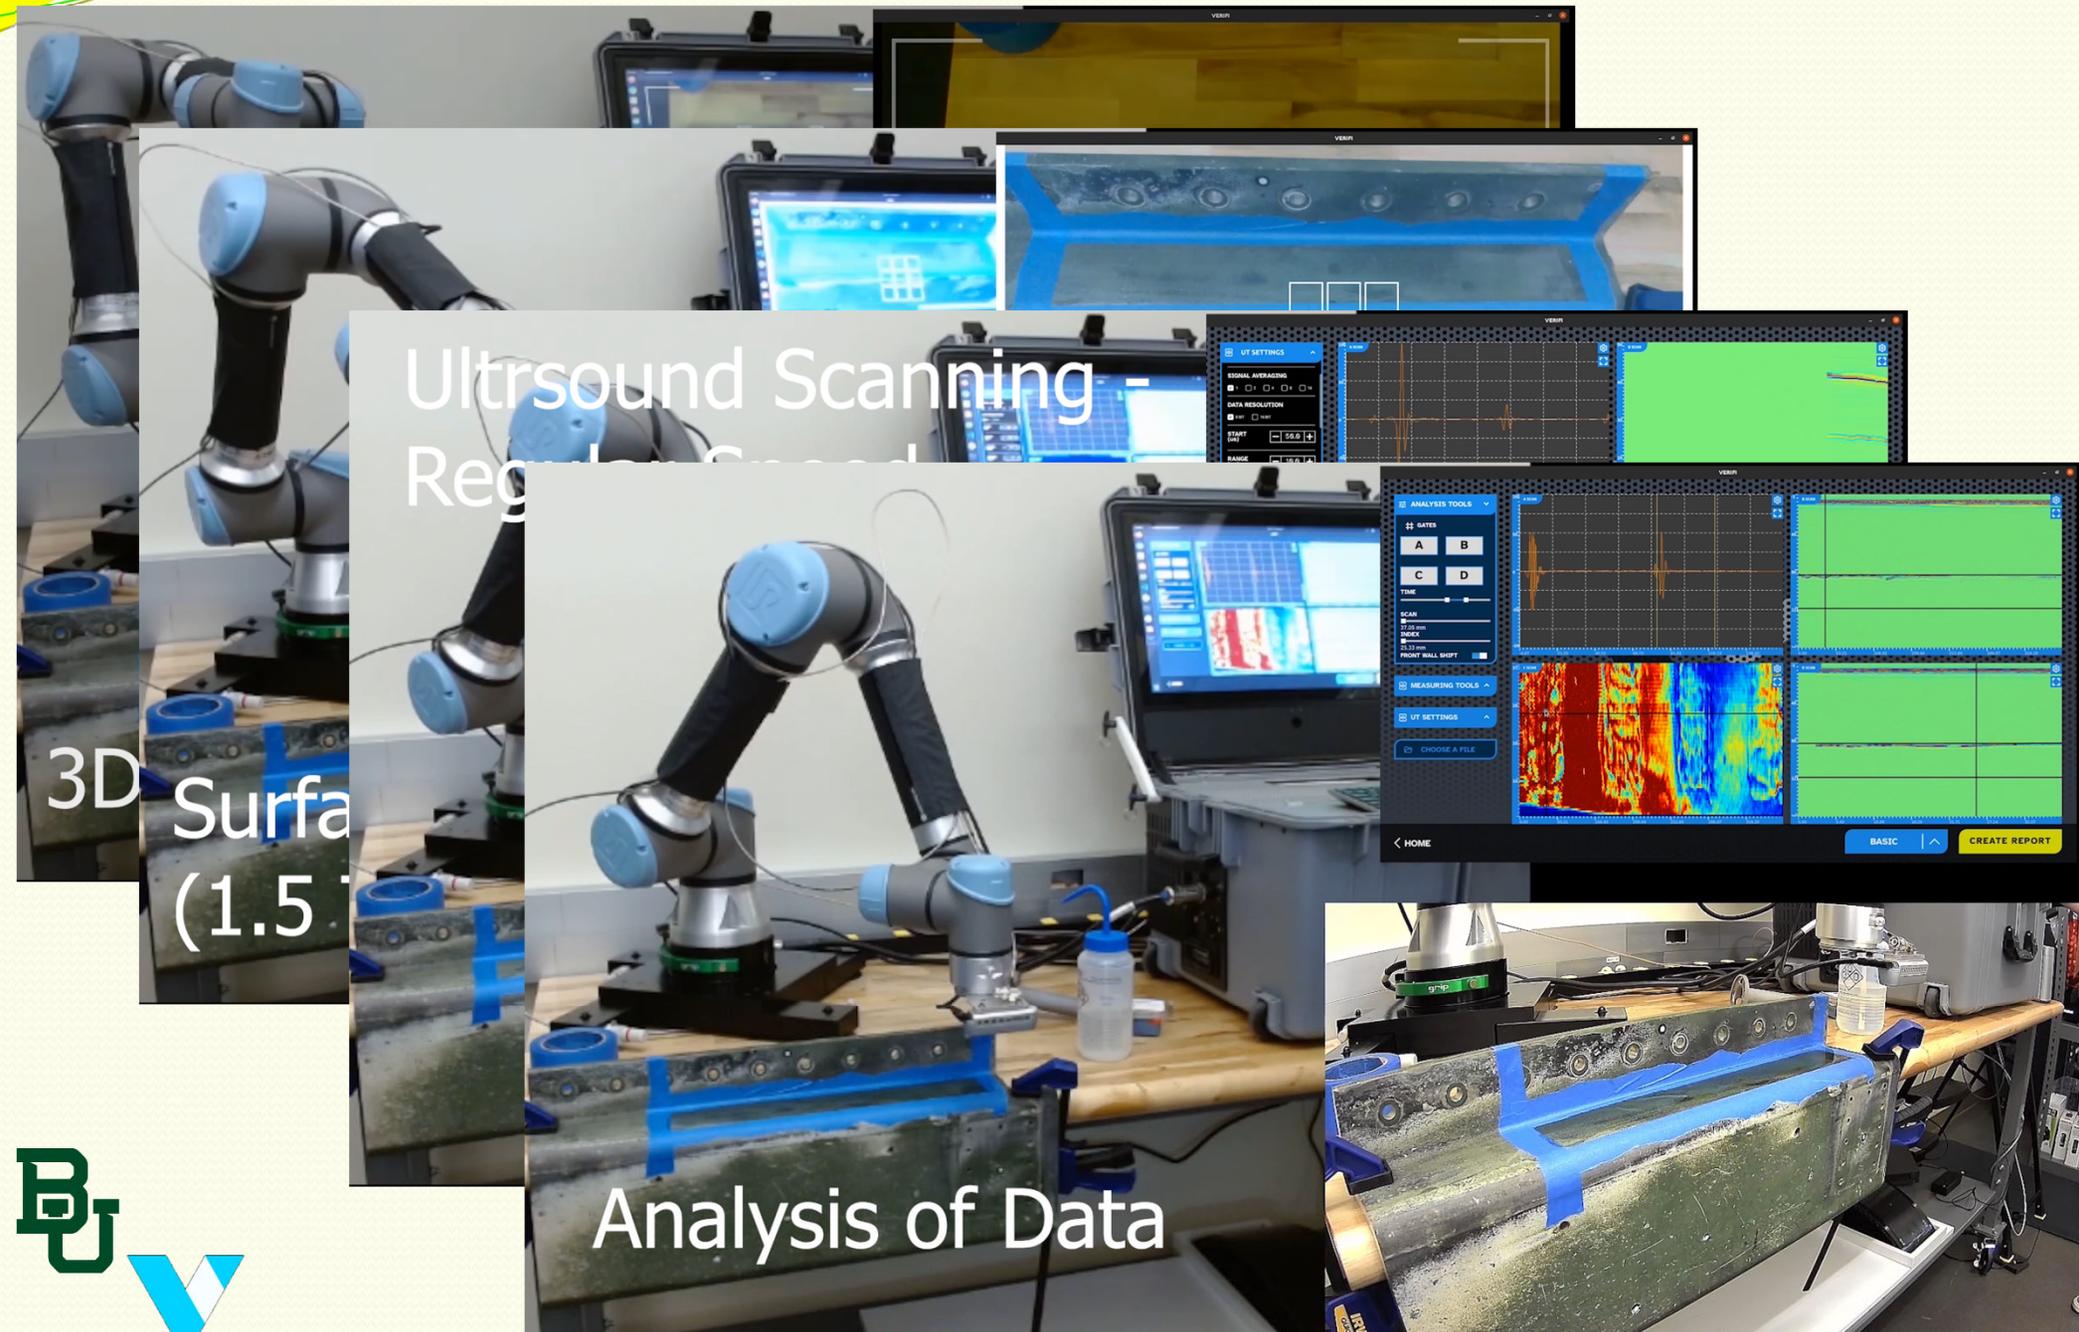
Typical Sequence of Operations for Inspection

Ultrasound Scanning -
Regular Control

3D Surface
(1.5)

Analysis of Data

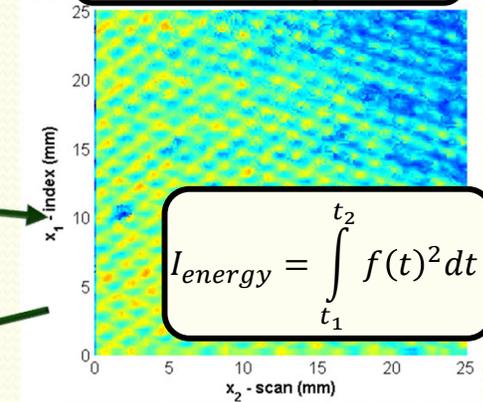
Extract Waveform
to Analyze

2D Transform in Spatial
Domain to Quantify
Orientation

Ply #	θ_i (deg)
1	14
2	68
3	2
...	...
N	30

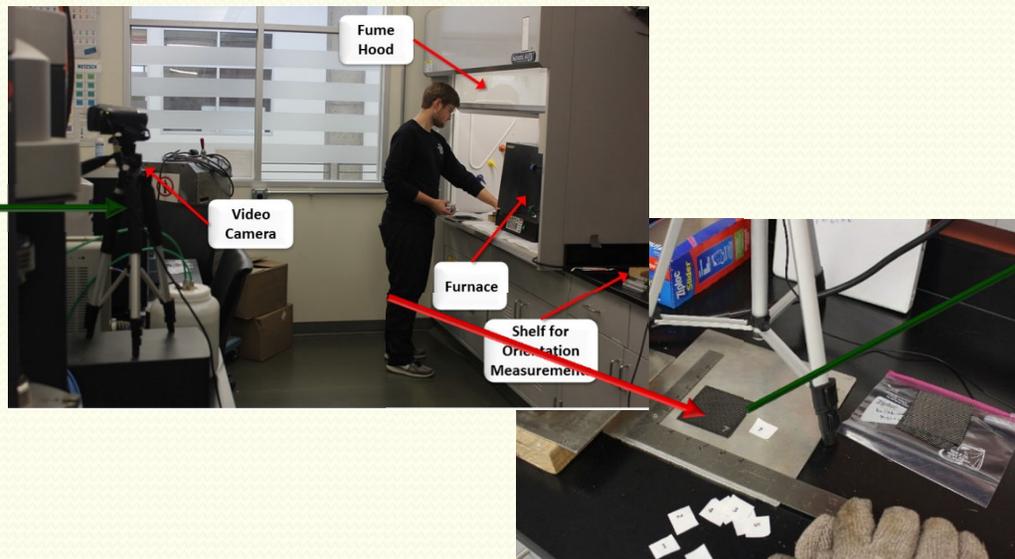
Validation by Thermal
Digestion

Check
Accuracy

Ply #	θ_i - NDI	θ_i Mfg.
1	14	15
2	68	71
3	2	1
...	...	
N^{th} Lamina	30	31

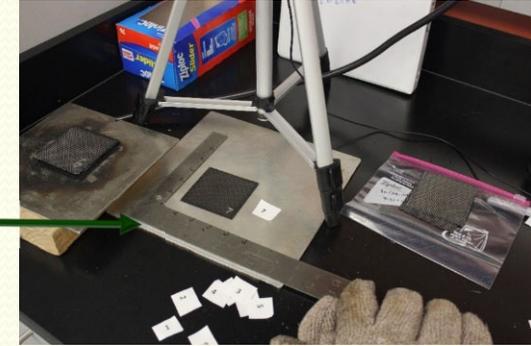
Validation

- Full study includes: woven carbon fiber laminates, 3 – 18 lamina coupons, environmental conditioning for > 90 days, inspection in the relevant environment

• Currently sitting at a >98% accuracy to within $\pm 2^\circ$

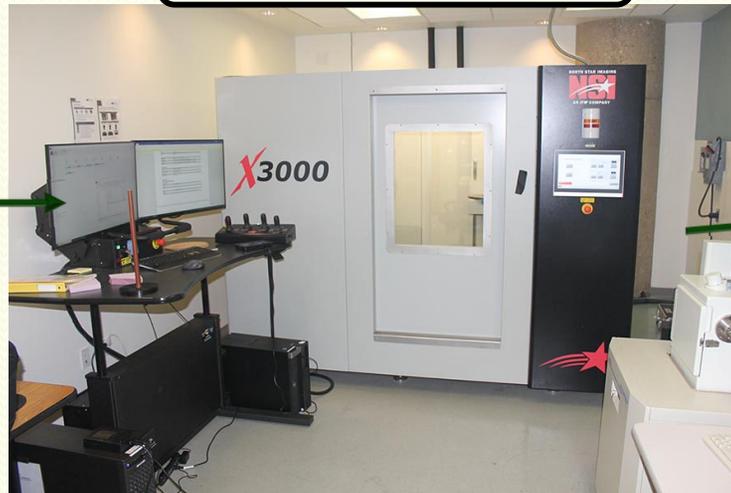
Validation by X-ray CT

- Composites are susceptible to service induced impact damage
 - Bird-Strike
 - Hail impact
 - Worker tool impact
 - FOD from ground surface
 - Etc.
- Knowledge of the geometry of the 3D damage zone will allow for proper decisions for when and where to repair
- This study quantifies the damage zone layer-by-layer for carbon fiber composite panels
 - **The inspection approach is completing an FAA 8100-9 Statement of Compliance with Airworthiness Standards (est. June 2023 finish)**
 - **The approach was successful in identifying and quantifying the 3D damage zone for every single panel**
 - Approach was validated using X-ray CT

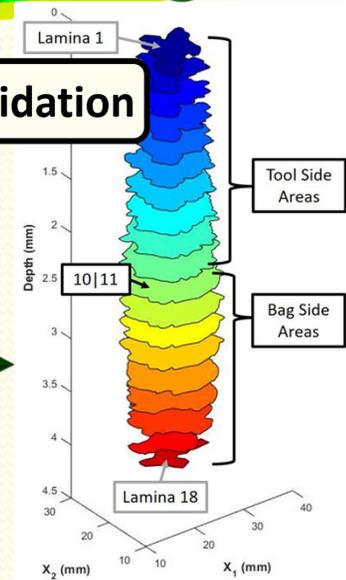
Validation

- Full study includes
 - Hybrid carbon fiber panels
 - 45 total coupons
 - Damage ranges from low, 8J – “undetectable”, to 16J “detectable”
 - Method goes beyond detection and quantifies the region of damage as a function of depth
 - Environmental conditioning for > 90 days
 - Conditions of 4°C ~ 50°C and 10%RH ~ 90%RH
 - Inspection in the relevant environment
 - Accuracy of ???

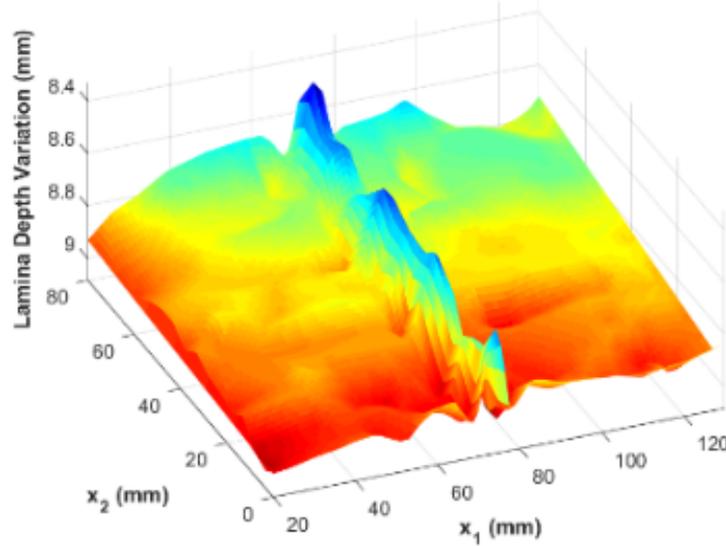
Wrinkle Detection

Track of Single Lamina, $\sim 6\mu s$ into part ($\sim 9mm$ into part)

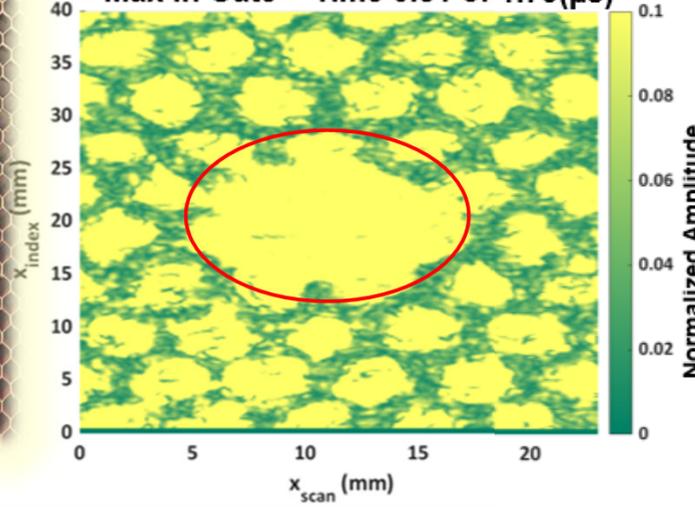
Honeycomb Adhesion Quantification

Max in Gate – Time 0.81 of 1.79(μs)
